# Effectiveness of Metal and Concrete Pipe Currently Installed in Missouri (Phase 2)

**FINAL REPORT**

RI07-058

**January 2008**

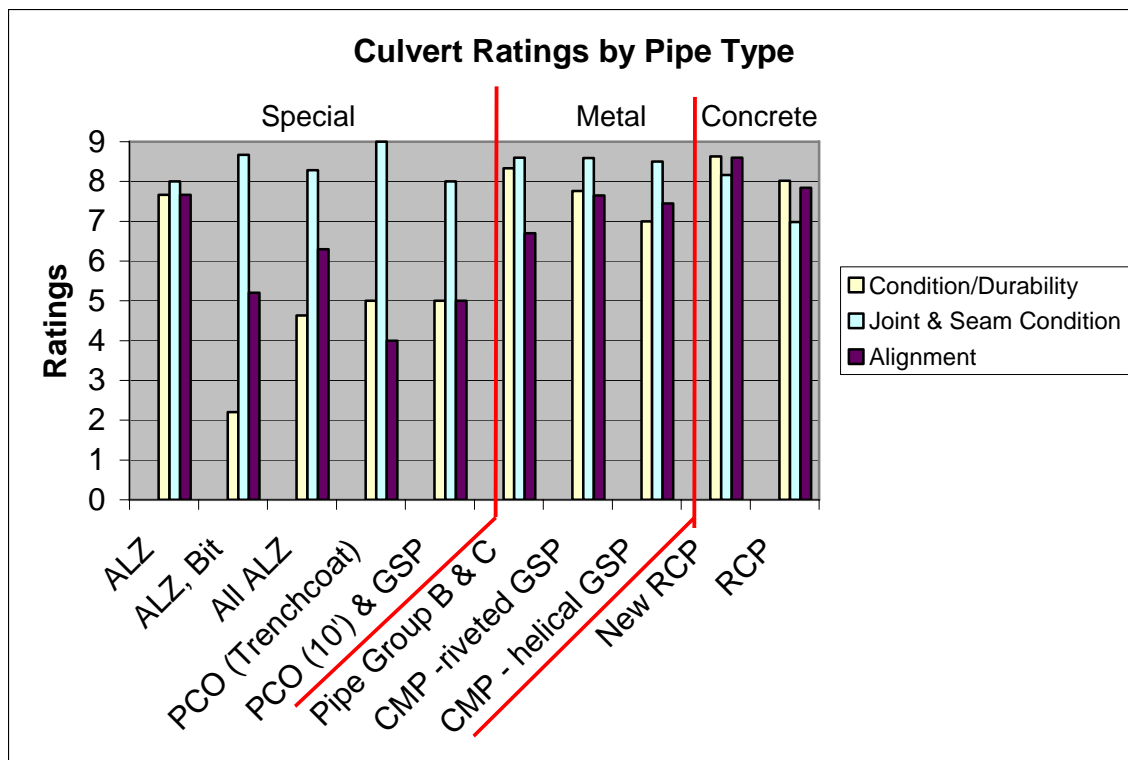
Figure 1:

The first chart, Figure 1, shows the average for each of the three rating scales (Condition/Durability, Joint and Seam Condition, and Alignment) of all the pipe of that material type. The second chart, Figure 2, is the overall rating average for each category of pipe.

Special metallic pipe are listed first. Aluminum Alloy pipes rate among the best of metallic pipe and it should be noted they are in the 33-45 years age group. Only three of these pipe were

inspected in this study and there is only a half dozen state wide because of the cost of solid aluminum alloy. Aluminized steel pipe was broken into two categories because the old bitumen coated aluminized pipes were in much worse condition than the uncoated aluminized which were rated high in all three criteria and overall with a 7.78 rating, next highest to Aluminum Alloy of the old in-place metal pipe. The bituminous coating was used in District 7 in known acidic areas, instead of just wearing off it must have trapped moisture and acid under it and caused a faster rate of corrosion. The next special material pipe is the polymer-coated steel, PCO. The first listed, located again in St. Clair County in District 7, is the only PCO entirely coated with Trenchcoat, a 3M coating used in 1997, when it was installed. This full-length polymer coated pipe was deteriorating at the outlet end where acid water runoff from this harsh area sat and damaged the pipe, thus it had a condition rating of 5. Another PCO pipe was installed in District 3 in 1990 but only experimentally using a 10 ft. section of the PCO pipe attached to a longer section of galvanized steel. The PCO part of this pipe, which was the inlet section, was rated 8, however, the galvanized steel CMP portion of the pipe had a condition rating of 5 because the invert was mostly covered with rust, this brought the overall rating to 6. These PCO pipe also have a problem of the outside coating deteriorating from ultra-violet light and the coating peeling off.

New galvanized steel CMP pipe are next and are listed as Group B & C pipe per the 2004 specifications. Even though these are new pipe installed after 2001 and have ratings above 8 for Durability and Joint and Seam Condition, they are rated below 7 on Alignment. These pipes are more flexible than concrete and need extra care taken when preparing the subgrade and backfilling, much like polyethylene (HDPE) pipe discussed in a previous report, Organizational Results Research Report OR08-002. The general CMP pipe, which are all galvanized steel pipe, are broken down into the older riveted corrugated plate sections and the newer helically wound corrugated types. The 18 CMP riveted were installed between 1993 to 2007 and had an overall rating of 8.0 slightly higher than the nine helical CMP installed between 1995 to 2002 with an overall inspection rating of 7.65. The ratings for Alignment were slightly less for the helical pipe. It was shown earlier that this pipe is flexible and can be damaged and punctured by rocks and the alignment changed if not backfilled properly.

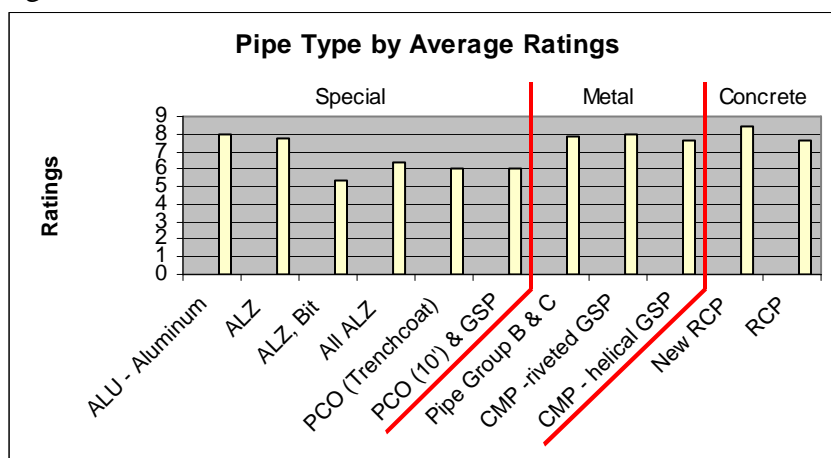
Figure 2:

That leaves only reinforced concrete pipe left (RCP), Group A in the 2004 specifications. The Condition and Alignment ratings are very high on these, over 8.5 for the new and near 8.0 for the older RCP pipe. The joints are the main problems and that rating was a little lower, 8.17 for the new and 6.98 for the older pipe. The overall rating for the 30 New RCP pipe installed 2002-2007 was 8.47 and for the 45 old RCP installed 1935-2001 was 7.61. Overall the Condition and Alignment ratings for concrete are better than metal but the Joint rating is more than one point less than metal pipe. It should be noted that the concrete pipe inspected in this study have been in service for as long as 72 years. Compare this to metal pipe inspected that have been in service only 5 to 14 years and one just installed in November 2007. If aluminized steel pipe are included in the metal category the oldest inspected was installed in 1952 and has been in service 55 years.
